# Environmental and Social Study and Action Plan for Project Eden

| <b>Report Title:</b> | Environmental and Social Study and Action Plan for Project Eden |

## Project Eden SITE PHOTOS

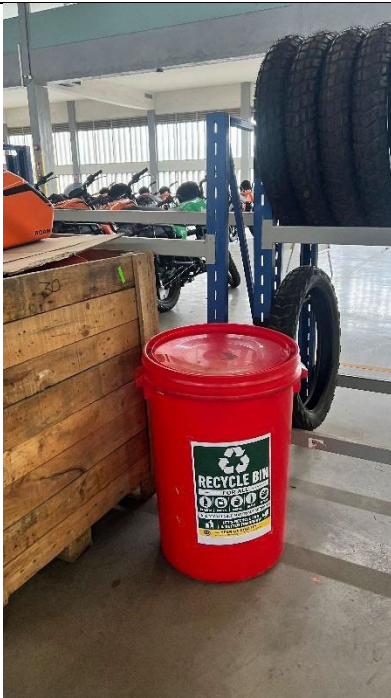
## f). Hazardous Materials & Waste Management

**Waste Management and Hazardous Materials (PS3 — High):** Hazardous waste storage in the basement is unlocked, unlabelled, and accessible to all personnel — a direct non-compliance with the Company's own Waste Management Procedure. Paint and solvent containers are stored on open, unmarked shelves, while being in a separate storage room. No MSDS register is available on site. While several recycler related documents have been signed, a formal contract with Enviroserve (battery recycling) has not been executed yet. No consolidated waste volume tracker exists. Spill response is not in place despite the presence of oils, solvents, and paints on site.

| | | Compliance Status | Comments | Recommendations |
|---|---|---|---|---|
| <b>3.2.12</b> | Are chemicals, oils and solvents properly stored, labelled and managed? | <b>N</b> | Site observation: paint and solvent containers in the basement stored on open, unlabelled shelves. No written handling procedure observed for paints, thinners, or cleaning agents. This is a direct non-compliance with the | Immediately label and secure solvent/paint storage (ESAP C1). Develop written handling procedures for lubricants, oils, solvents, and cleaning agents. Add spill kit to paint booth and grinding room. |

| | | Compliance Status | Comments | Recommendations |
|---|---|---|---|---|
| <b>3.2.14</b> | Does the Facility have spill prevention and response measures in place? | <b>N</b> | Spill response was marked N/A in the Company's information request response. However, grease/oils, solvents, and paints are present on site. A basic spill containment and response protocol is required under IFC PS3 and WBG EHS Guidelines. No spill kits were observed in the basement storage or paint booth areas. | Develop a basic spill containment and response procedure for oils and solvents. Procure spill kits for the paint booth and grinding room (ESAP C6). |

| | | Compliance Status | Comments | Recommendations |
|---|---|---|---|---|
| 3.2.4 | Is waste segregated at source and stored safely at all sites? Has the Facility availed Waste segregation and management equipment? | P | Waste segregation at source observed at the Headquarters — labelled bins in place. However, the hazardous waste storage area in the basement is not | Immediately secure and label the hazardous waste storage area. Restrict access to trained personnel. Label all hazardous material containers. |
